Manhole Inspection Summary

Manhole # S49AA_016MH

Insp Date: **7/10/08 11:34 AM**

Location Address: **Milton**

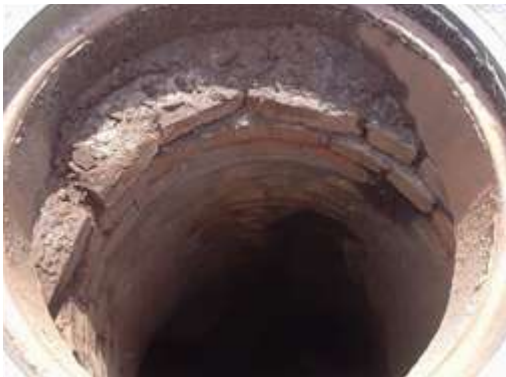
Defect 1

Condition: ☐ Sound ☐ Cracked ☐ Root Intrusion ☒ **Loose Brick** ☐ Deteriorated

Infiltration: ☐ None ☒ **Joint** ☐ Cracks ☒ **Mortar** ☐ Roots ☐ Wall

loose brick

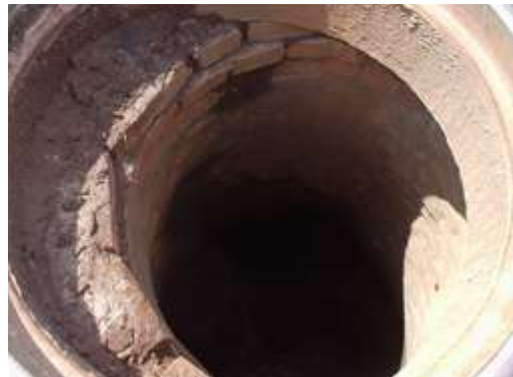
Defect 2

Offset: **5** (in.)

offset

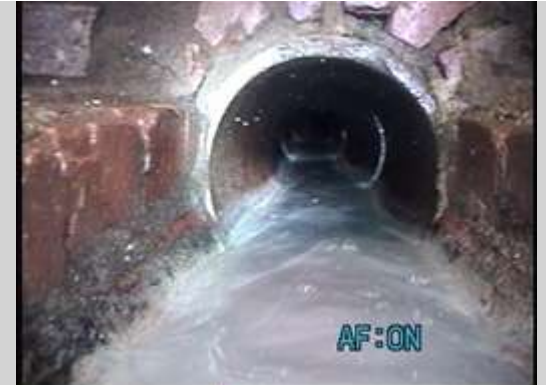
12 O'Clock Outflow

Pipe Height: **8.4** (in.) Rod and Bar (Angled)
Pipe Material: **Clay** ☐ Pipe Lined
Invert Depth: **12.35** (ft.) Flow Characteristics: **Fast**
Deposits: ☒ None ☐ Mud ☐ Sludge ☐ Debris ☐ Grease
Silt Depth: (in.) Deposits Extent:
Infiltration: **None** Pipe Seal Cond: **Sound**

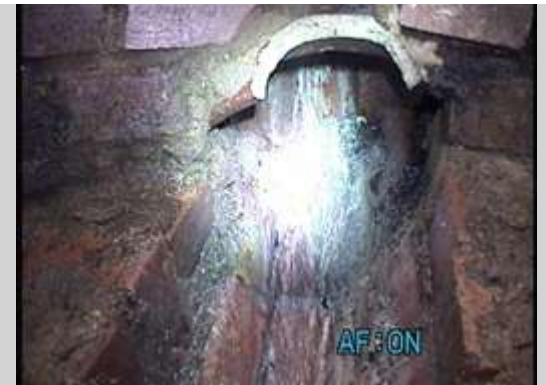
3 O'Clock Inflow

Pipe Height: **8.4** (in.) Rod and Bar (Angled)
Pipe Material: **Clay** ☐ Pipe Lined
Invert Depth: **10.50** (ft.) Flow Characteristics: **Fast**
Deposits: ☒ None ☐ Mud ☐ Sludge ☐ Debris ☐ Grease
Silt Depth: (in.) Deposits Extent:
Infiltration: **None** Pipe Seal Cond: **Sound**

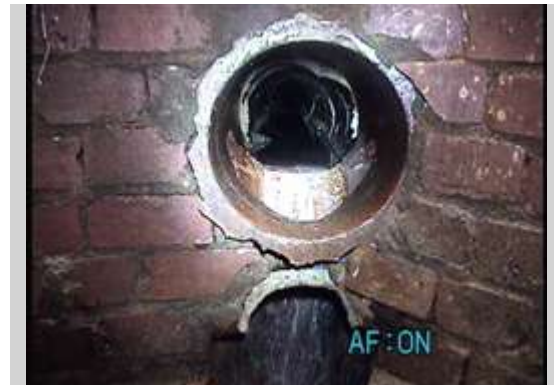
Drop In @ 3 O'Clock

Drop: **Inside** Rod and Bar
Angled: **Yes** Reading: **10.80** (ft.)
Inv Depth: **11.80** (ft.)
Drop Condition: **Open**

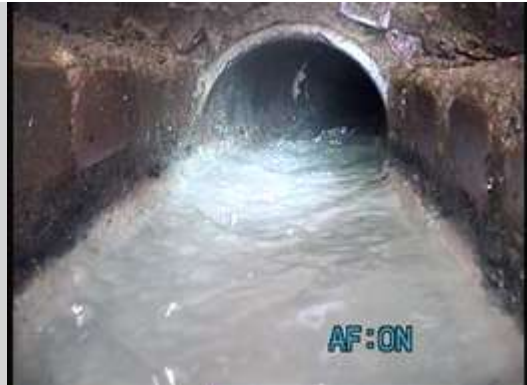
6 O'Clock Inflow

Infiltration: **None** Pipe Seal Cond: **Sound**
